NASA TN D-2577

PERFORMANCE OF SEVERAL
ABLATION MATERIALS EXPOSED
TO LOW CONVECTIVE HEATING
RATES IN AN ARC-JET STREAM

by Marvin B. Dow and William D. Brewer

Langley Research Center

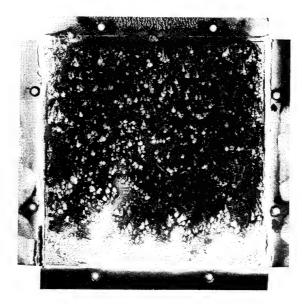
(b) Material A.

Material A.- This material changed in color from a light brown to a dark brown during exposure to the low-level heating. There was no visible evidence of combustion during this period. The high-level heating caused visible combustion on the surface with a gradual removal of material which exposed what appeared to be a matting of quartz fibers. Some cracks and local checking appeared on the surface during the high-level heating.

Figure 8(b) shows the material after exposure to the simulated pulse. The surface of the specimen after testing was flat, with no distortions or serious defects other than the cracks and checking noted previously. The outer surface of the material was hard, and considerable pressure was required to rub charred material from the surface. The weight of material lost from the two specimens exposed to the simulated pulse was in close agreement and was approximately 30 percent. The temperature of the beryllium backup plate at the end of the simulated pulse showed some variation among the four test specimens. This variation in temperature may have been caused by the distribution of the quartz in the ablation material.

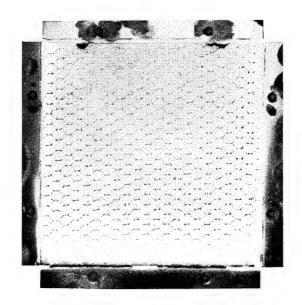
(d) Material C.

Material C.- Combustion, producing visible flames, occurred on the surface of the specimens of material C during low-level heating. Blisters and fissures appeared in the material near the end of the low-level heating period. When the heating was increased to the high level, the rate of combustion increased appreciably. The fissures in the material widened, and localized burning occurred in the region of the fissures. The ablation material separated from the beryllium backup plate in the region of the most severe heating, which was the edge of the specimen nearest the arc-jet nozzle.

Figure 8(d) shows the specimen after exposure to the simulated pulse. Material C was seriously affected by oxidation with nearly a 50-percent material weight loss. The blisters and fissures which appeared during testing are visible in figure 8(d). The beryllium backup plate reached a temperature of 600° F $(589^{\circ}$ K) before the end of the simulated pulse. (See table III.)

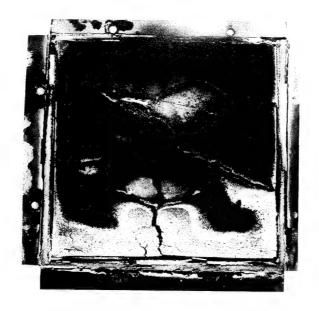
(f) Material E.

Material E.- During exposure to low-level heating, material E changed in color from a medium brown to black, with no visible evidence of combustion. The high-level heating caused visible combustion on the surface. There was no blistering, separation, or loss of material from the honeycomb during testing. This material was also tested in an arc-jet stream of nitrogen and air and evidenced less visible combustion during high-level heating in this test stream, but otherwise it performed in the same manner as in the air tests.

Material E, after exposure to the simulated pulse in air, is shown in figure 8(f). The surface of the material was rough but regular, with the honeycomb cell walls apparently having oxidized at a slower rate than the ablation material. The weight of material lost during the simulated pulse in air was about 45 percent of the weight before testing and about 30 percent for the corresponding test in nitrogen and air.

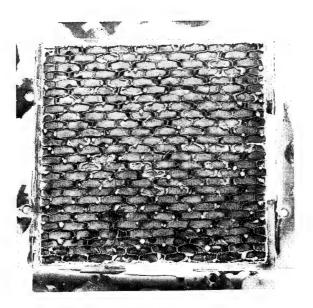
(h) Material F (tested in air and nitrogen). L-64-8362

Material F. - Low-level heating in air caused combustion of material F, with visible flames over the entire surface of the material. Cracks formed in the surface of the material, and localized combustion occurred in the regions of the

cracks. High-level heating caused increased oxidation on the surface of the material. Cracks penetrating the entire depth of the ablation material developed, and the material blistered and separated from the aluminum backup plate in the region of the most severe heating.

Tests of the material in an arc-jet stream of reduced oxygen concentration resulted in less severe oxidation, even though flames were visible during both low- and high-level heating. The cracking and separation of material was also less severe than for the tests in air.

The ablation material F is shown in figures 8(g) and 8(h) after exposure to the simulated pulse in air and at reduced oxygen concentration, respectively. The cracks and separations of the material, which are similar in appearance to those which occurred with material C, can be seen in the photographs. The char layer produced by the tests in air extended in depth to the aluminum plate, with no unpyrolized material remaining. The material experienced a 66-percent weight loss during tests in air.

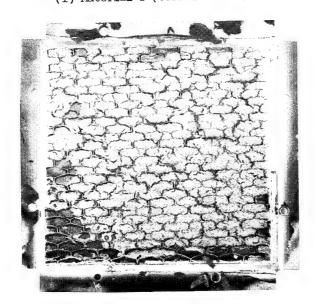
(i) Material G (tested in air).

Material G.- Specimens of material G differed from all others tested in that the rectangular fiber-glass honeycomb cells had low-density insulation between the metal backup plate and the ablation material. The ablation material was applied in a thin layer at the top of the cells and across the exterior surface of the specimens to give a smooth surface. When this material was exposed to low-level heating during a simulated pulse in air, a thin char layer formed at the surface, oxidized, and produced visible flames. The burning stopped after a few seconds, and the material in each cell appeared to expand outward with continued exposure. With the application of high-level heating, the thin char layer was rapidly oxidized and the insulation material in the honeycomb cells shrank away from the cell walls. Near the end of the high-level heating period, a portion of the insulation material in some honeycomb cells blew out and beads of glassy material were seen to form on the outer edges of most honeycomb walls. The formation of beads indicated that high local heating on the exposed edges was melting the glass in the honeycomb. When exposed to a simulated pulse in the arc-jet stream of reduced oxygen concentration. material G behaved as it did in air during the low-level heating. However, exposure to the high-level heating produced no noticeable change in the appearance of the material. The char layer was not oxidized, nor was there any melting of the edges of honeycomb walls.

Figures 8(i) and 8(j) show material G after exposure to a simulated pulse in air and at reduced oxygen concentration, respectively. The glass beads which formed on the edges of the honeycomb walls are visible in figure 8(i). During tests in air, the ablation material G was completely consumed, and the specimens experienced a 56-percent weight loss. Material G tested at reduced oxygen concentration experienced a weight loss of about 45 percent.

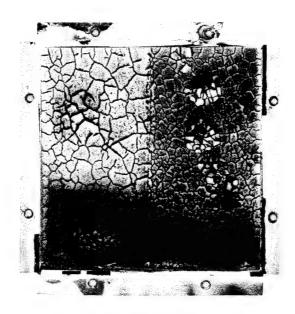
(k) Material H.

Material H.- The protective coating on material H burned off quickly on exposure to low-level heating. With the protective coating gone, the interface in the center of the specimen between the differently applied sections of material H was evident. The low-level heating produced no visible reactions or changes in the material. The temperature of the beryllium backup plate rose continuously during low-level heating, as shown in figure 7(i). When the heating was increased to the high level, the surface of the specimen began to burn with green-colored flames. The half of the specimen covered by the sprayed-on and self-bonding material H developed an overall small-grain crack pattern; several large blisters which buckled the surface of the material also appeared. The section of adhesively bonded material H covering the other half of the specimen developed a large-grain crack pattern over most of the surface. Near the end of the high-level heating period, separation of this material from the beryllium backup plate occurred in the region of maximum heating.

The photograph of figure 8(k) shows a specimen of material H after exposure to the simulated pulse in air. The crack patterns and blistering are evident in the photograph. The surface cracking probably resulted from shrinkage of the thermally degraded material, and the blistering was probably caused by gas, formed during heating, which was unable to escape to the surface. Similar blisters developed in material H in other tests in the 2500-kilowatt arc jet at the Langley Research Center. (For example, see fig. 6(h) of ref. 4.) During exposure to the simulated pulse, the material experienced a 38-percent loss in weight.

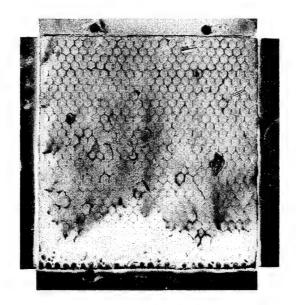
(1) Material I.

Material I.- The surface of material I burned with visible flames upon initial exposure to low-level heating, but after a few seconds the visible flames disappeared. The material in the honeycomb cells appeared to swell outward, and in several individual cells the material was pushed completely out of the cell. Near the end of the low-level heating period the thermally degraded surface layer appeared to separate from the material beneath and to produce large

blistered regions extending across several cells. When the heating was increased to the high level there was surface combustion, and visible flames were produced. Some of this material was blown completely out of several of the cells, and there was localized burning around such cell holes. Also, the material continued to separate into blistered regions in the same manner as during low-level heating.

Figure 8(1) shows a specimen of material I after a simulated pulse in air. Individual cells from which the material blew out are visible in the photograph. The thin white layer of thermally degraded material which developed during the tests was distorted and irregular; this layer was extremely fragile, however, and had testing been conducted with a higher velocity air stream, it is likely that this layer would have been removed. Beneath the thin residue, the pyrolyzed material was hard and tough, but irregular. Material I experienced a weight loss of about 10 percent during exposure to the simulated pulse, thus indicating good resistance to oxidation. Examination of the temperature curves shown in figure 7 shows that the back-surface temperature for this material was higher than for any other material tested at corresponding times up to about 140 seconds of exposure; however, between 140 seconds and 160 seconds the backsurface temperature appeared to be reaching an equilibrium value. When the heating rate was increased, the back-surface temperature again increased but at a slower rate than during the low-level heating. It is believed that the backsurface temperatures of this material were markedly influenced by the considerable expansion of this material during heating. Examination of a sectioned specimen indicated that the thickness of the material after testing was nearly twice that before testing. This increasing thickness resulted from the expansion of the material up and out of the honeycomb cells. The expansion of material I increased the material thickness and decreased its density, thus giving it better insulation properties. Therefore, the thermal performance appeared to improve with longer exposure.

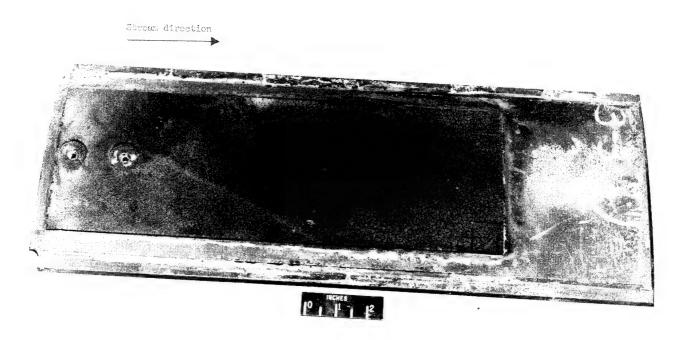
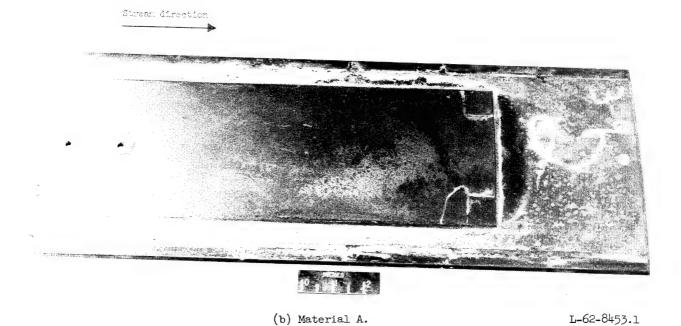
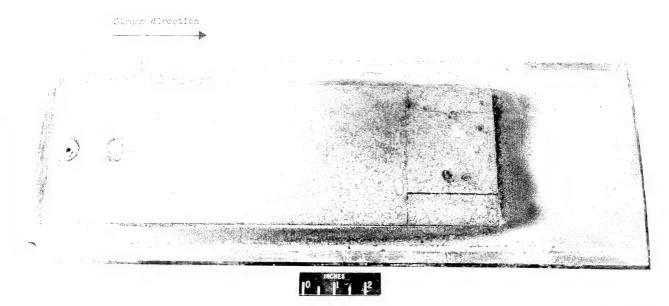
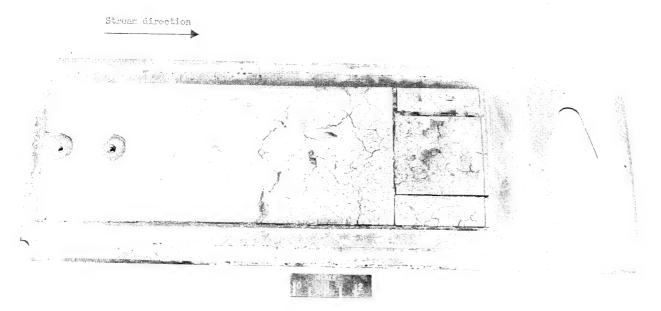
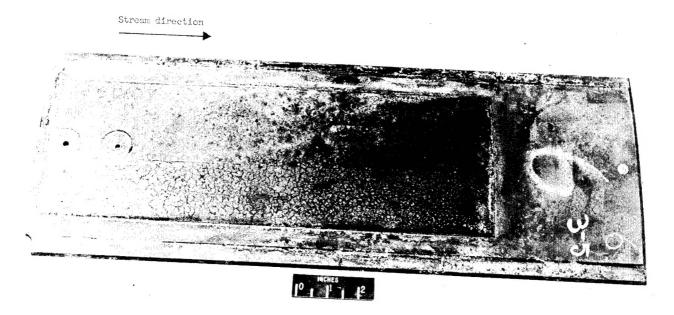
Figure 10.- Flight-test specimens after reentry.

Specimens of each type of ablation material after the flight test on the MA-8 spacecraft are shown in figure 10. The photographs show the materials as they appeared on the beryllium afterbody shingles after spacecraft recovery. A comparison of the ablation materials which were flight tested and the arc-jet specimens in figure 8 indicates that the materials were less severely damaged in flight than in the arc-jet environment. This difference in damage may have resulted from unduly severe oxidation in the arc-jet environment. It is also

possible that the flight specimens did not receive heating as great as the arcjet panels because of their position on the afterbody of the MA-8 spacecraft.

A comparison of the physical appearance of the specimens tested in flight (fig. 10) and the specimens tested in the arc jet (fig. 8) shows considerable similarity in the appearance of most of the materials. The similarity in appearance is apparent for phenolic nylon and for materials A, C, E, and H. There is some similarity between the appearance of the flight-tested specimen of material I (fig. 10(g)) and the specimen tested in the arc jet (fig. 8(1)). The surface of the flight-tested specimens of material I was apparently discolored by deposition of its ablation products on the specimen surface or some other material which may have been ablation products from the forebody heat shield. In the region of most severe heating on the flight specimen, however, there are several honeycomb cells from which the material is gone. This type of failure was also observed during arc-jet tests. The specimen of material D tested in flight (fig. 10(e)) did not have the white friable surface layer that formed during the arc-jet tests of this material. This difference in appearance may have been caused by the degraded surface layer having been blown off the flight specimen, or the reentry heating may not have been sufficient to cause thermal degradation of the material. The appearance of the flight-tested material B (fig. 10(c)) is considerably different from the appearance of this material after arc-jet testing (fig. 8(c)). Much less of the material was consumed during the flight test, and the black sooty surface layer which developed during arc-jet testing is not present.
